THE CHERRY HILLS LANDSLIDE TRAGEDY

Emilio MORALES; Marissa CAMACLANG; Gilberto REYES

Chairman, PICE Geotechnical Committee; Member, PICE Geotechnical Committee;
Member, PICE Geotechnical Committee;

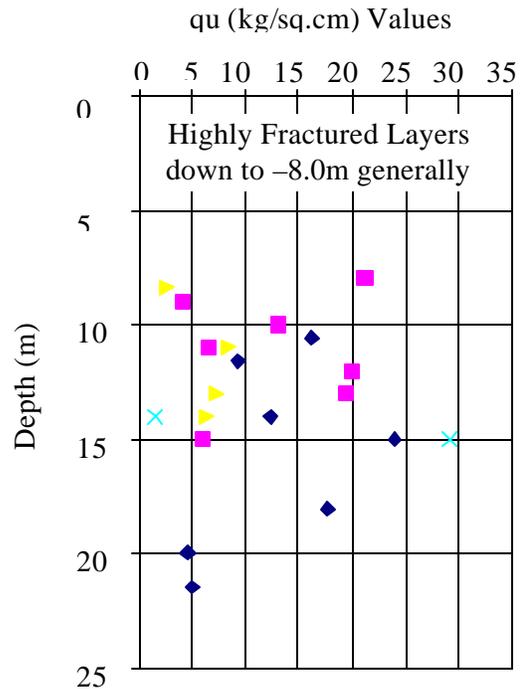
Fig.1 qu vs. depth for intact rock cores from Borings.

The Scatter Chart in **Figure 1.0** below shows the values for both rock types obtained from the borings.

Although these represent the material strengths of the intact rocks from a generic sense, it does not give an idea as to the actual *Characteristic Rock Mass Strength (CRMS)* during the slide. The *Characteristic Rock Mass Strength* is the "average" strength of the rocks along the failure plane at failure.

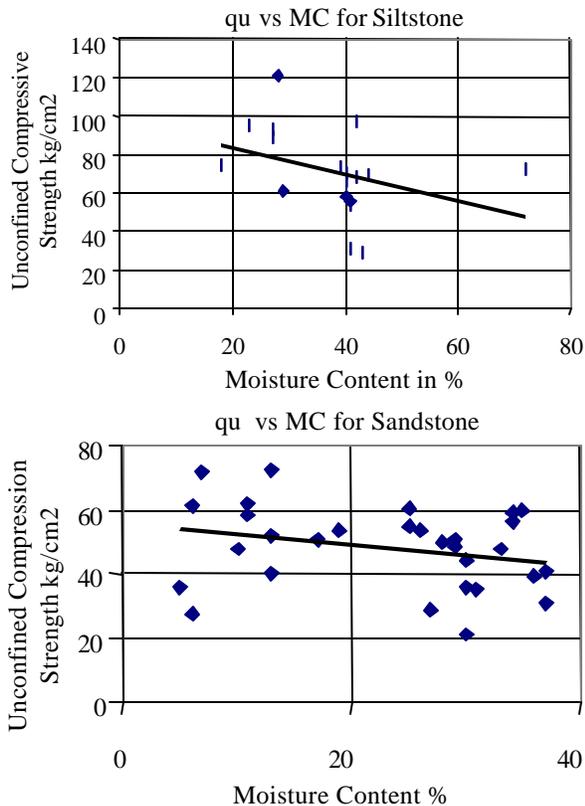
Fig.2 Unconfined Compressive Strength for Intact Sandstone and Siltstone Cores.

The plot of the Unconfined Compressive Strength **qu** (kg/cm^2) vs. Moisture Content (%) is presented in **Figure 2.0** for Sandstone and Siltstone Cores.

The trendline indicate the decrease in **qu** with increasing moisture content clearly establishing that water saturation could have an effect on the strengths.

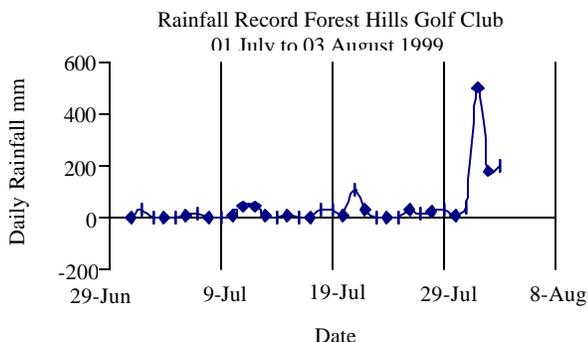
Fig.3 Rainfall Chart Preceding the Landslide Event

This phenomenon was followed by abnormally high rainfalls in the months and days immediately preceding the slide. (**Fig. 3.0**)

The two weeks preceding the landslide have seen the heaviest rainfall in the area in many years with the last 3 days immediately before the major landslide event the heaviest ever encountered.

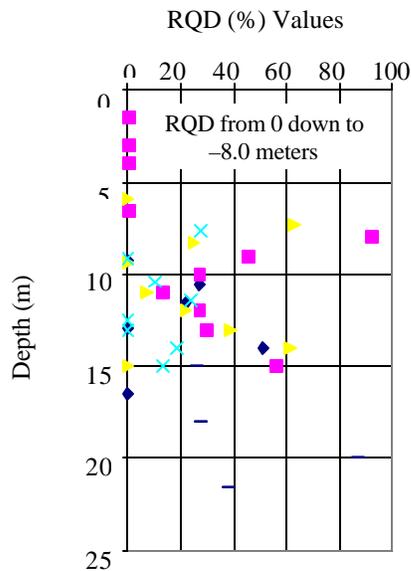
Fig.4 RQD vs. Depth for various core samples extracted from Field Borings.

In addition, it gave an indication of the Rock Quality through the percentage core recoveries and also through its Rock Quality Designation (*RQD*) values. The plot of the *RQD* values taken from the immediate area from 4 Boreholes and numerous core samples are shown in a Scatter Chart, **Figure 4.0**.

The RQD values as can be seen are relatively very low and indicate the highly fractured condition of the rock materials even in the undisturbed areas.

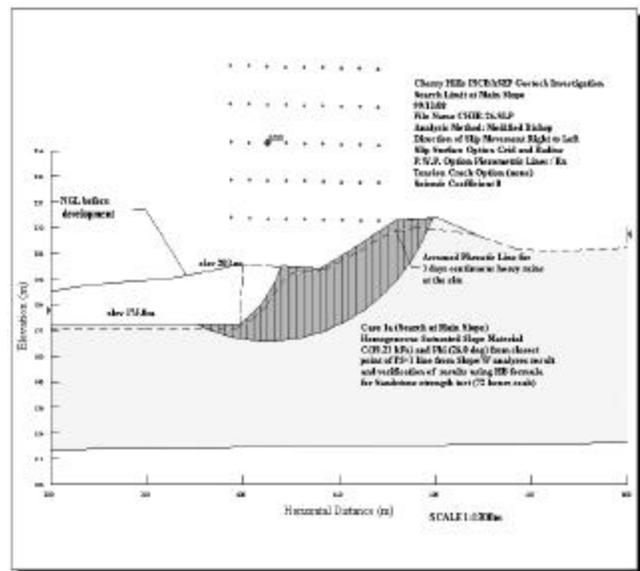
A conventional “*First Pass*” slope stability analysis was conducted using the *Characteristic Fractured Rock Mass Strength* in order to define potential failure planes. This would aid in identifying where the critical conditions are, based on the slope geometries and characteristic Rock Mass Strength. Cohesion and Friction Angle (c_m and f_m). The computer program was allowed to automatically search for these critical slip circles from which candidate locations as defined by low factors of safety were recorded. In addition, the search area was also concentrated on suspect critical areas in order to fully understand how the slide occurred and whether there was a single massive slide or a sequence of slides occurring one after the other within a few seconds.

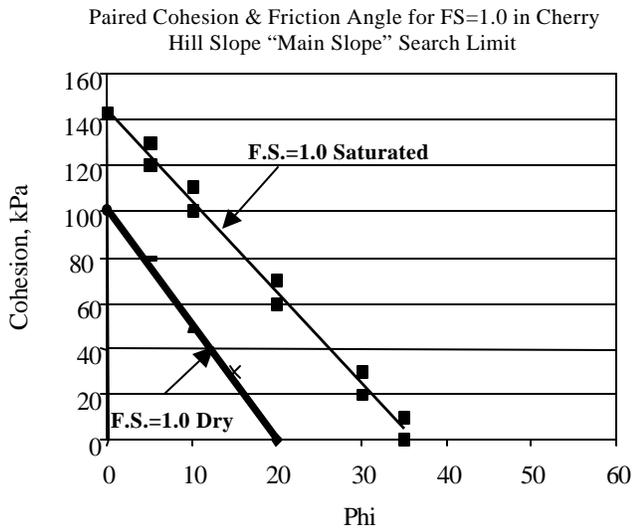
Fig.5 Results of Back Analyses for Dry and Saturated Slope Conditions

The paired values (**c**, **f**) obtained were then plotted in a chart of Cohesion vs. Friction Angle as shown in **Fig. 5.0**.

The procedure was conducted for both dry and saturated slope. (*Figures 5 and 6*)

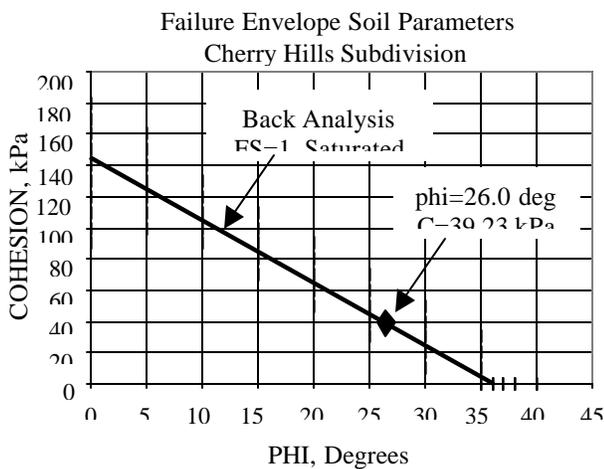
Fig.6 Failure Envelope from Back Analyses

It is significant to emphasize what the above plot is telling us, which are:

- For the same failure situation (**FS=1.0**) higher strength parameters (**c & f**) would need to be mobilized at saturated conditions to prevent failure. (*Failure occurs at higher strengths*)
- Conversely, for dry conditions, lower strength parameters (**c & f**) would suffice to prevent a failure condition from occurring.

saturation and consequent pore pressure buildup was the most likely mode of failure. The family of points show the possible combinations (paired values) of (**c & f**) likely to cause failure.

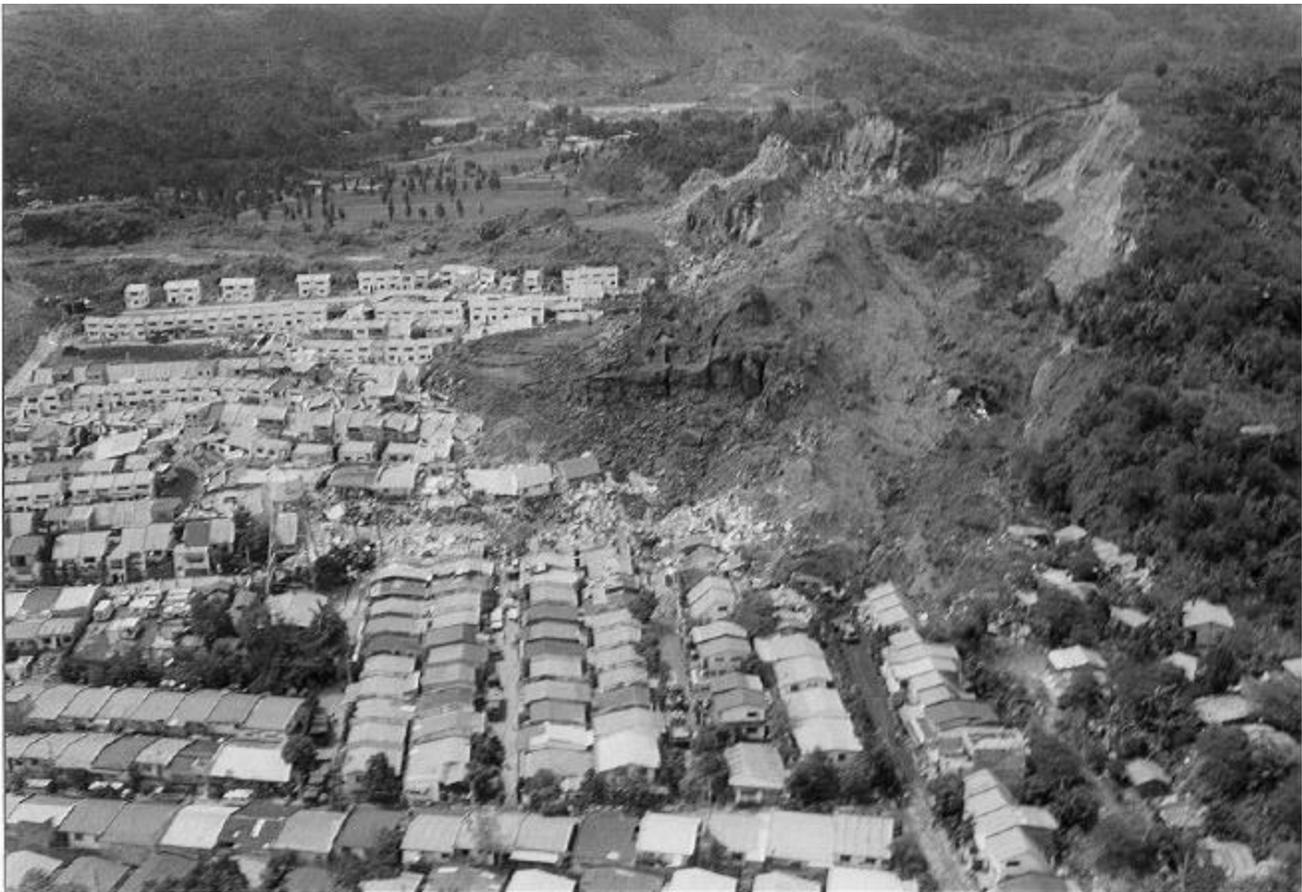
In the three days, August 1, 2 & 3 immediately preceding the landslide of August 3, 1999, record rainfall levels were experienced with the highest level of 500 mm occurring on August 2, 1999.

With the record level of rainfall, development of near full Hydrostatic Pore Pressure was possible. The diversion or blocking of intermittent and continuous surface streams by the landslide movement can add surface water (which originally flowed elsewhere) to the groundwater in the slide area.
